Rework Instruction V2

Infantry Assault Vehicle

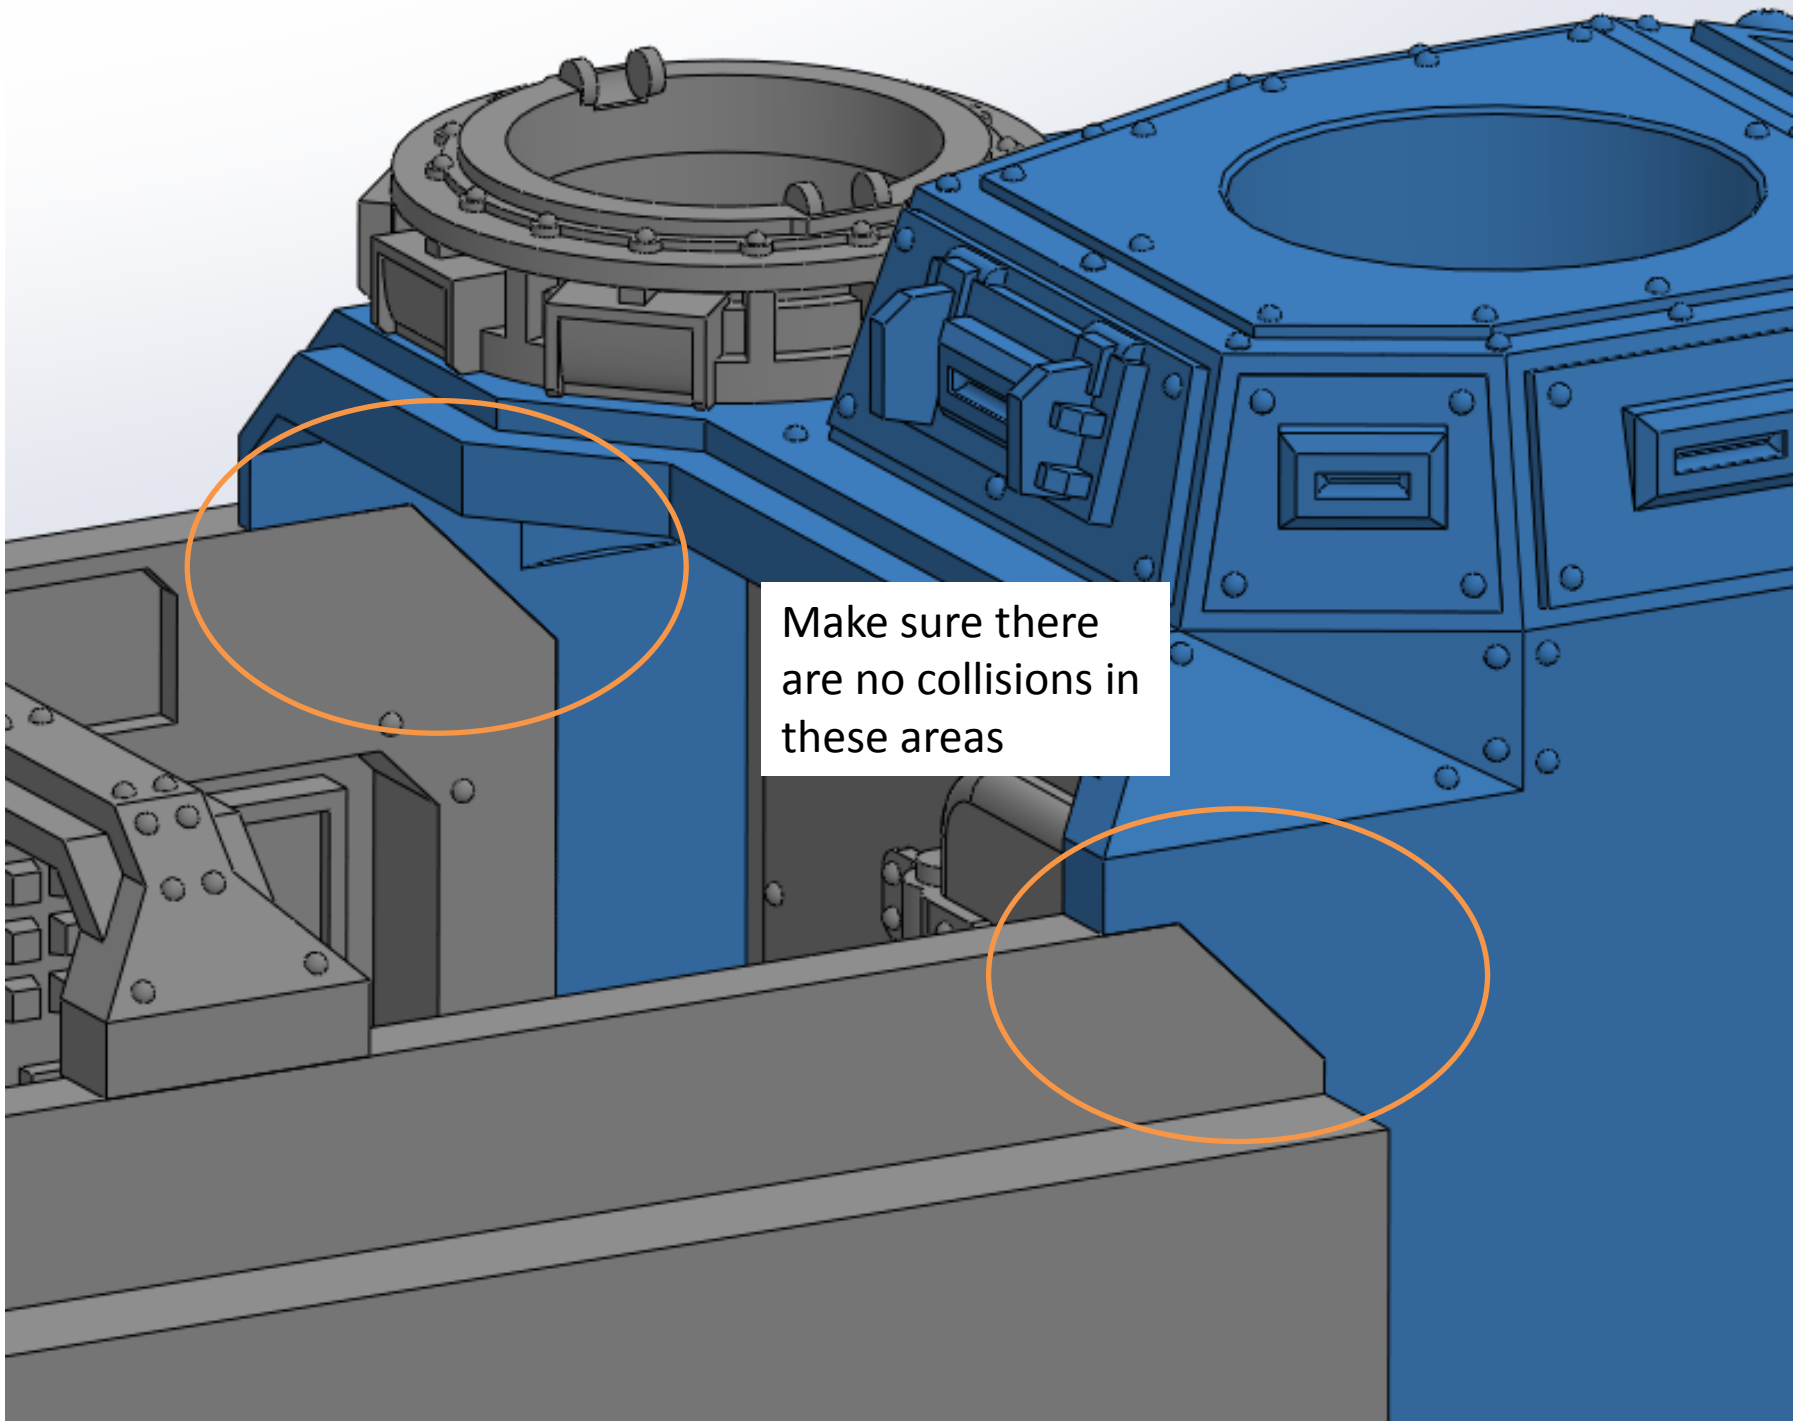
Make sure there are no collisions in these areas

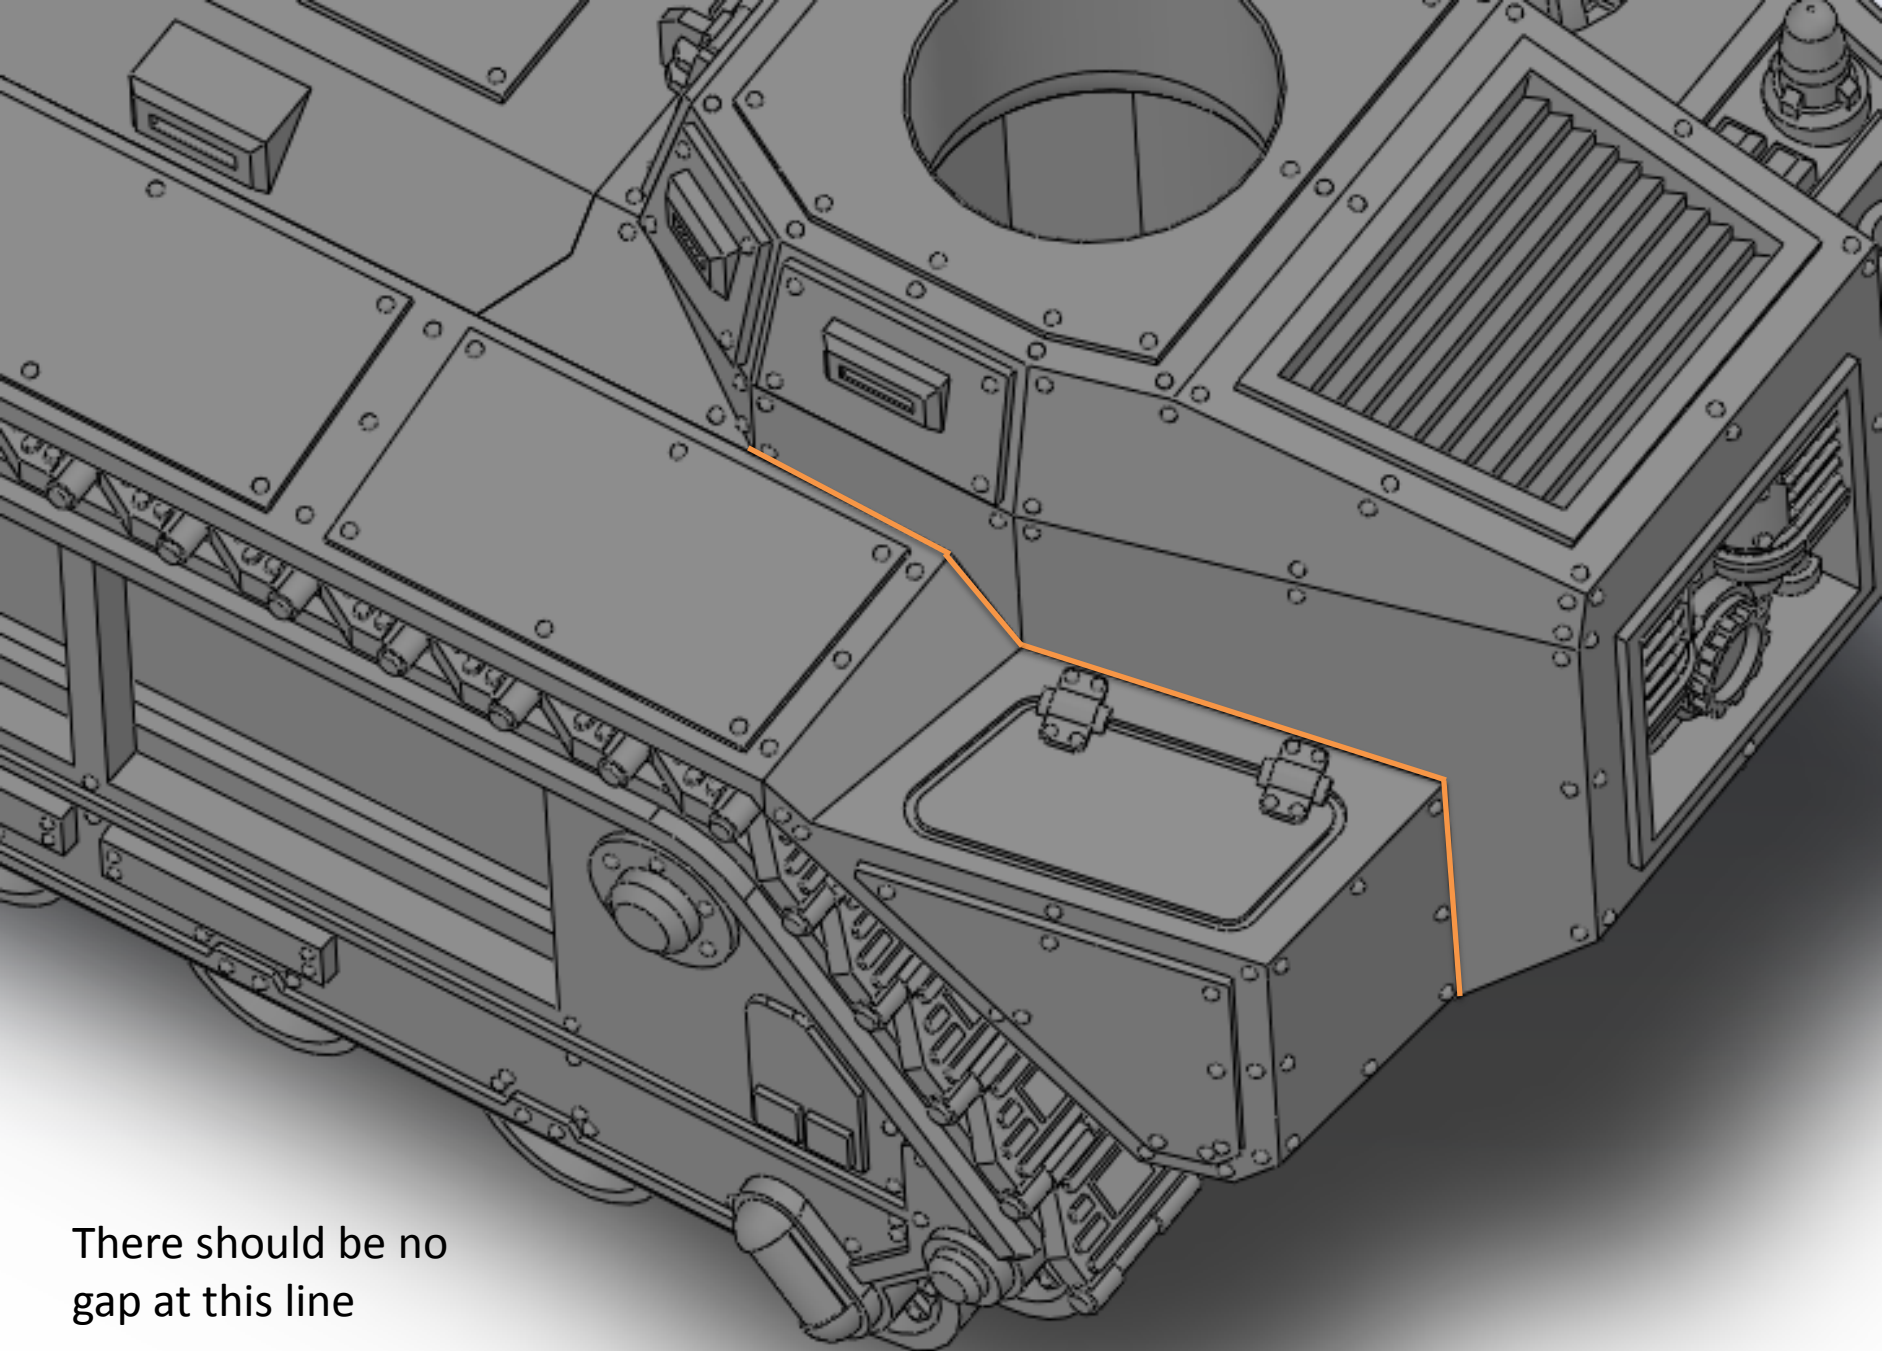
There should be no gap at this line

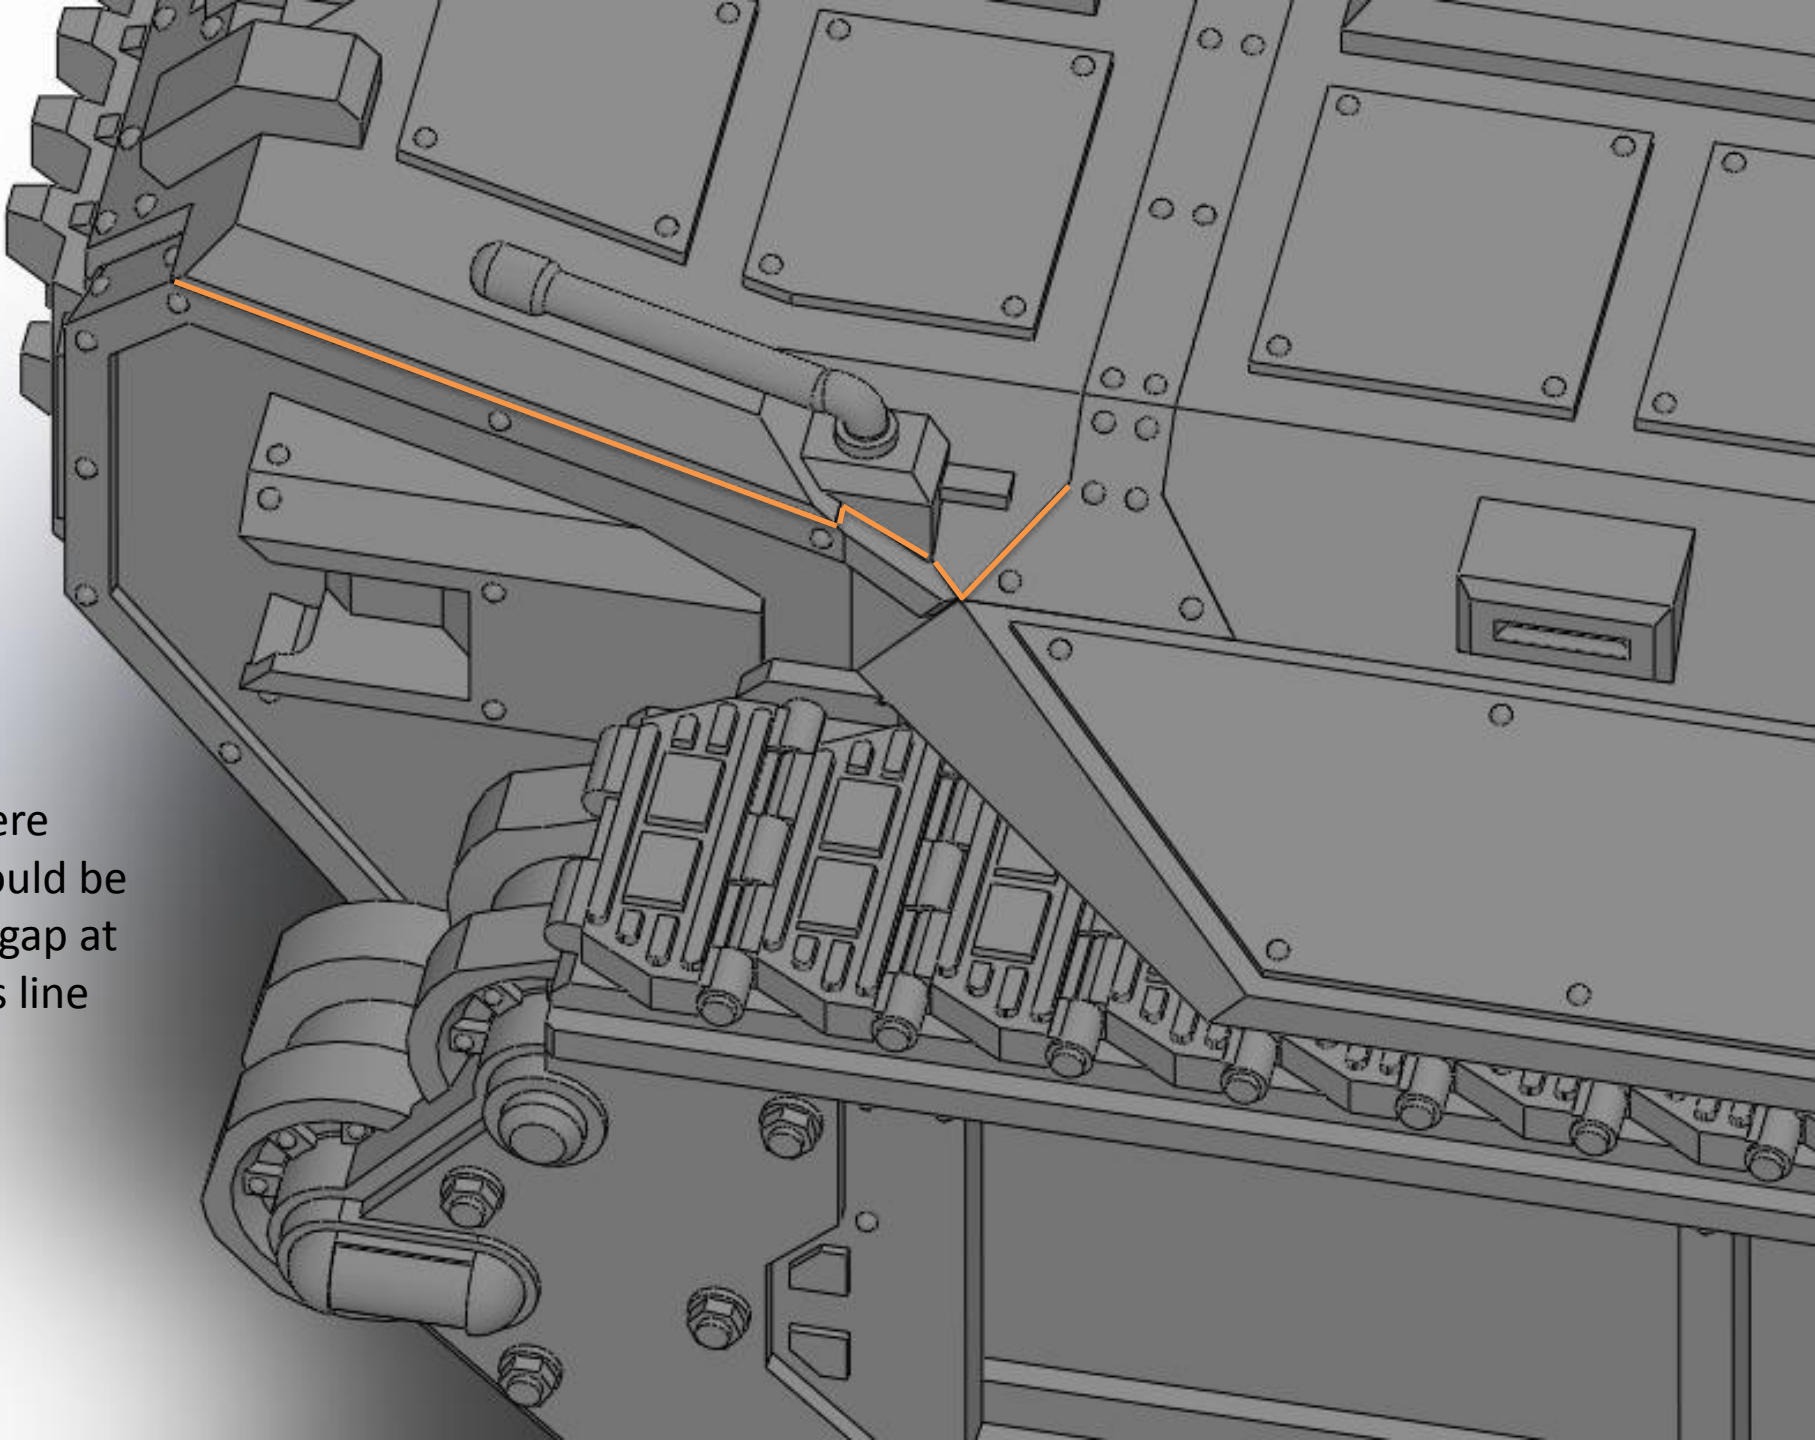
There should be no gap at this line
